USING STREAMBANK RESTORATION AND  
BEST MANAGEMENT PRACTICES FOR  
IMPROVING WATER QUALITY  
WITHIN CRAWFORD BRANCH,  
IN ROBERTSON COUNTY,  
TENNESSEE

A Thesis  
Presented for the  
Masters of Science  
Degree  
Austin Peay State University

May 2004

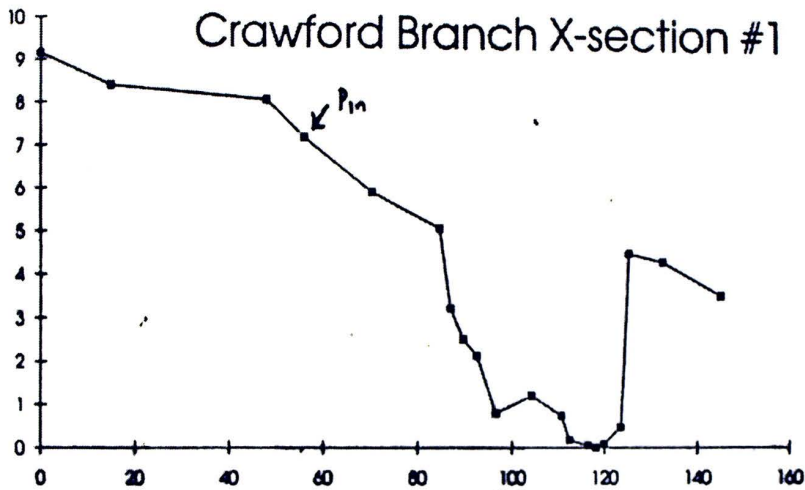
Fig. 3. The 1996 Cross-sectional survey of site three Crawford Branch.

Site three monitoring area was 25 m in length, and the height of the streambank to thalweg was 3 m. Before remediation took place, the streambank was cut on a 90° angle. The stream flow within this reach was shallow and over 90° percent riffle-erosive flow (Fig. 3).

The streambank was showing the classic mechanisms for bank failure including erosive attack at the toe, failure of the overlying bank (forming a wave-type action, Fig. 3), erosion of the banks (face of slope) caused by shear stress, or sloughing of streambanks by water seepage (sub-surface and overland flow) out of the bank, and freeze-thaw action of unvegetated and unprotected banks (shrinking and swelling of clay-type soils that are often associated with the riparian zone) (Henderson, 1986).

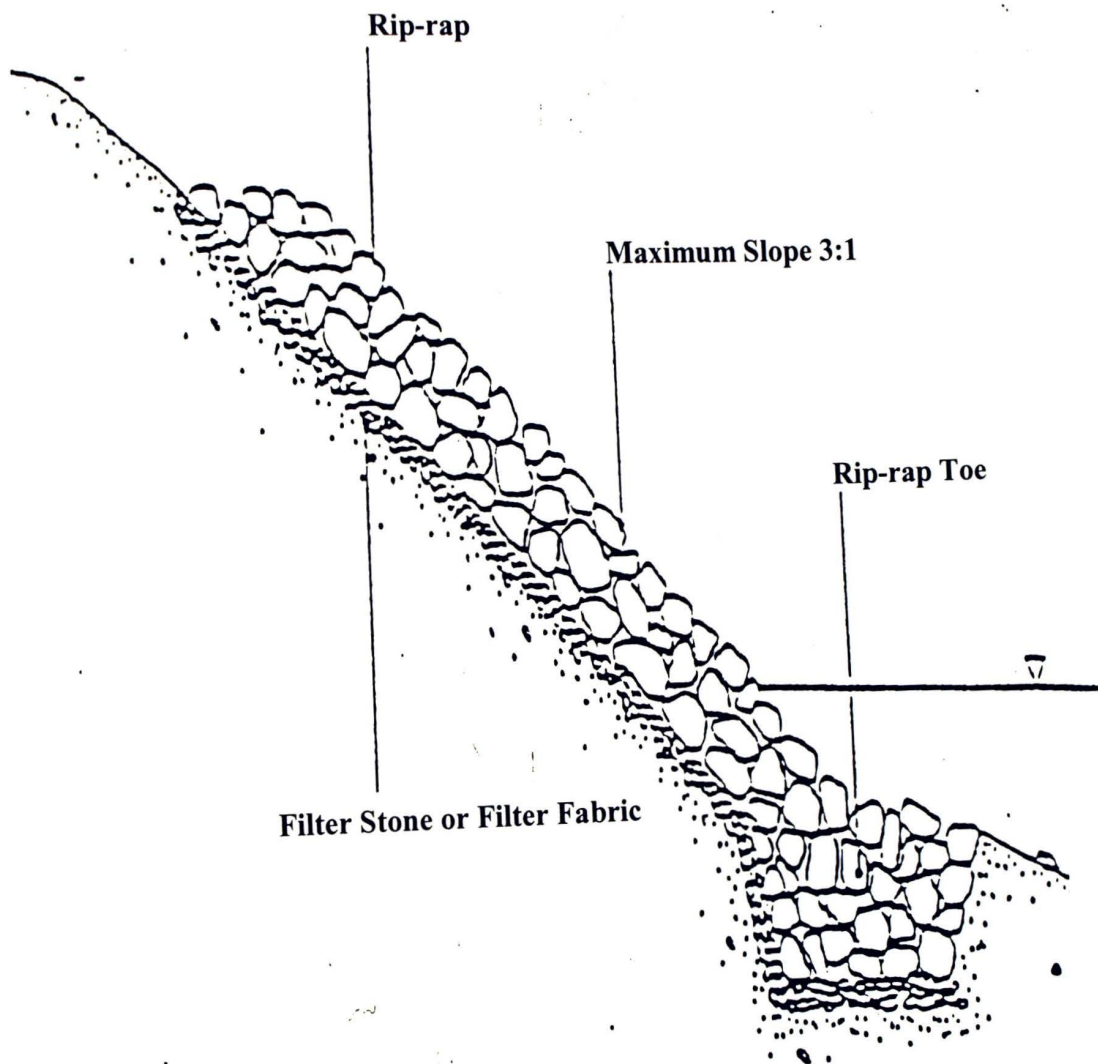
Fig. 4: Conventional streambank armoring and remediation

The flow of Crawford Branch deflected off of a gravel bar located 20 m downstream of New Cut Road Bridge and dead-ended into the upstream end of site one. Without any riparian vegetation to hold the soil in place, several large scour holes developed in the streambank. From an offsite project, the landowner obtained several large sections of broken concrete. The concrete sections were “dumped” into the scour holes by the landowner in an attempt to stop the excessive bank erosion and retreat.

The planned remediations of site one began during the first week of July 1997 and were as follows: use a backhoe to spread the concrete sections out to get them flat against the streambank and anchor them into the streambed (one-half of the bottom layer of stone should be below stream grade) (Thompson, et. al., 1994). This created a layer of protection for the toe and prevented additional scouring and under-cutting of the streambank. Also, the sections of concrete were situated to add protection to the streambank above the splash zone. This process mimicked a widely used method known as conventional bank armoring (Fig. 4). Bank armoring basically involves rip-rap stone that is usually greater than 30 cm- in diameter and 45 to 50 kg, or of sufficient size to prevent washing downstream (Thompson et. al., 1994). Larger stone should be placed at the lower elevation to ensure that the largest crevices are available for aquatic habitat.

The upper portion of streambank was sloped on a 2:1 ratio to alleviate the physical stress of the over-hanging bank. From the top of the concrete sections, 13 trees were transplanted on 09, July 1997. The decision was made to transplant the trees late in the year due to un-seasonable cool temperatures. In 1997, the average temperature for the month of June was 18° C (United States Department of Agriculture National Agricultural Statistics Service, 1997).

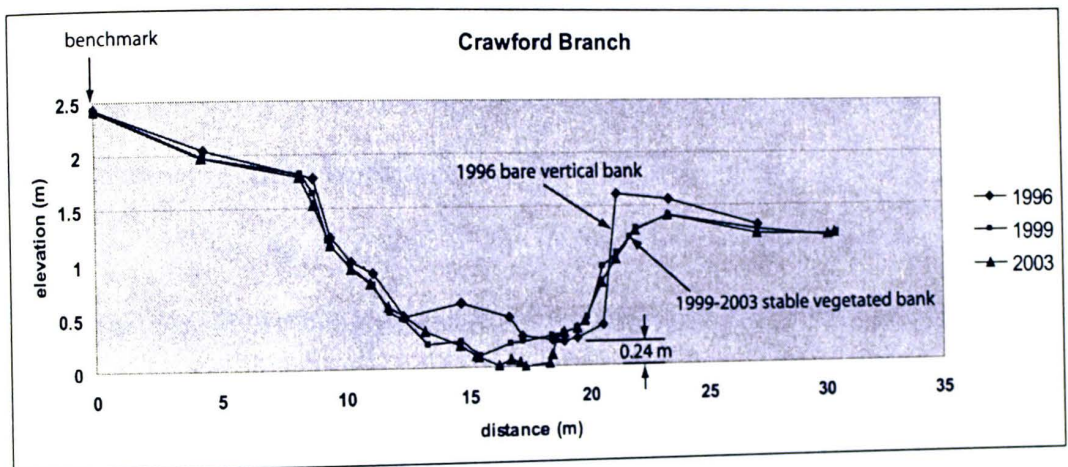
Fig. 11: The 1996-2003 Cross-sectional surveys of site three, Crawford Branch

The diverted flow has removed a gravel bar located within an incipient floodplain on the right side of the stream channel. The bank treatment has resulted in a straighter thalweg and volume reduction of the gravel bar (Smith, 2003). All seventeen transplanted trees within the riparian area have survived. The seeds of trees and herbaceous plants have germinated in the interstices of the rock and have further developed the riparian buffer zone. The additional vegetation includes trees such as cottonwoods, sycamores, box elders, and black willows. In addition, a variety of herbaceous plants have mixed in with the seeded grasses.

Fescue and other grasses have developed into a solid ground cover that extends from the existing hay land to the rip- rap revetment. The thick mat of grass has aided in trapping fine sediment in high erosive in-stream and overland flows. Throughout the years, the riparian zone of Crawford Branch and Carr Creek has been planted five different times. This was done to extend the buffer zone, increase the trapping and removal of sediment and nutrients, add wildlife habitat, shading for the stream, and create a mixture of un-even aged trees, shrubs.

A persistent problem is that the landowner is renting the land to a local farmer. That person is cutting the field for hay, and in doing so he is maximizing the field by cutting the riparian zone to the top edge of the streambank. The hay cutting has eliminated every tree planted in the buffer zone. The solution may be to fence the riparian area completely off the hay field. Fencing will eliminate the cutting of the

riparian zone during haying operations. This will allow the vegetation to mature and develop, and increase the functions of: absorbing excess nutrients, trapping sediment and providing wildlife habitat. From past experiences, the fence needs to be placed within the five- year flood zone at a minimum. This will reduce damage from flooding waters and maintenance cost for repairs.
