County MONT

Temp. Field # 66F-G12-123

Architectural Data: Construction: Frame \_\_\_\_\_ Log \_\_\_\_\_ Brick ☒ Stone \_\_\_\_\_

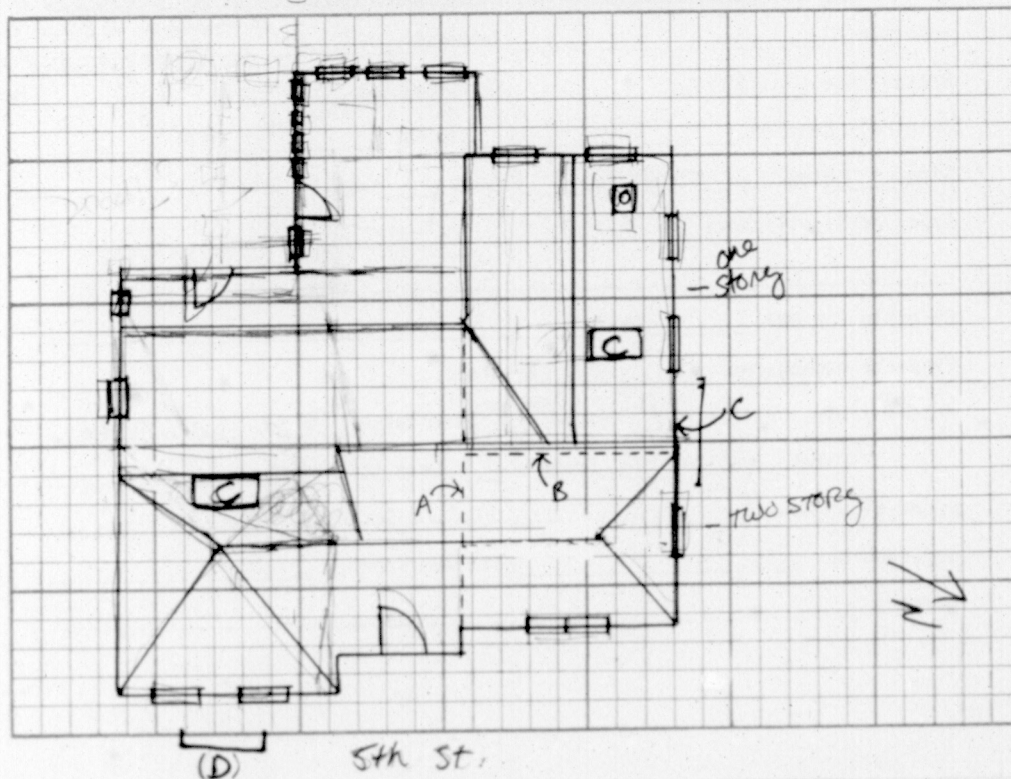
Architectural Notes The owner points out that interior wall (A) has very  
clean plaster joints and suggests that it may have been an outside wall  
at one time. Owner also notes that interior wall (B) was added after

outer wall (C) and is not bonded with (C)  
Sketch Plan Below (include North, door and window locations, etc.):

Round window heads (D) suggest late construction
