USING STREAMBANK RESTORATION AND  
BEST MANAGEMENT PRACTICES FOR  
IMPROVING WATER QUALITY  
WITHIN CRAWFORD BRANCH,  
IN ROBERTSON COUNTY,  
TENNESSEE

A Thesis  
Presented for the  
Masters of Science  
Degree  
Austin Peay State University

May 2004

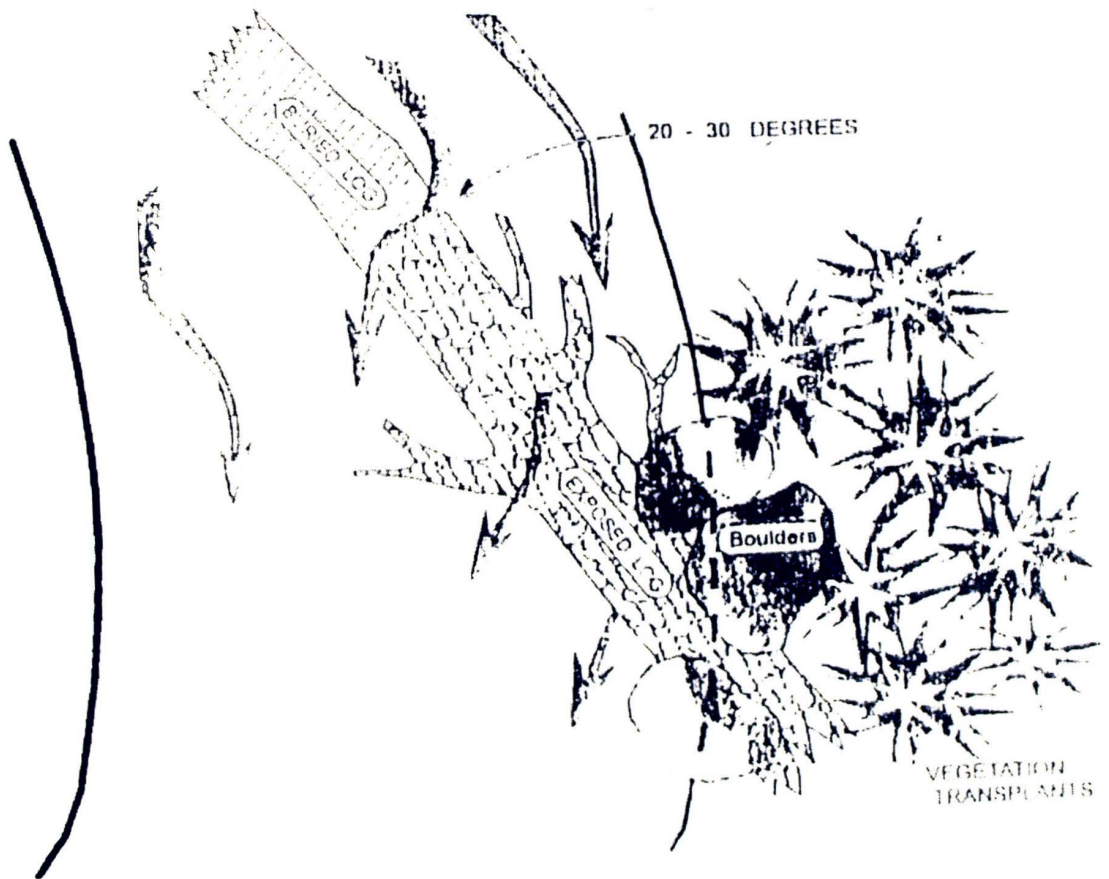
Fig. 5: Log deflector design and construction

This site contained the log deflector at the upper-most project area. A combination of cedar trees and rip-rap revetment was used for toe stabilization downstream of the deflector. Deflectors are one of the most common used methods of habitat restoration and streambank stabilization. They can be relatively inexpensive, modified for each location, and built from natural and local materials (Thompson et al., 1994). The hydrologic benefits from deflectors include: the formation of scour pools, shelter pools, and increases riffle-pool sequences. Studies have shown that fish production has doubled through the use of deflectors (Thompson et al., 1994). The deflector in site two has not only diverted thalweg away from the bank, but has created 0.5 m wide gravel bars that extend back upstream the full length of the left bank of site one (Fig. 7). Also, the deflector placement has resulted in development of a 1.5 m gravel bar along the opposite bank of site two that extends almost to site three (Fig. 10). This is slowly creating a more sinuous flow and increasing the residence time, velocities and depths of the channel reach.

Site two project area was 25 m in length and was located on the “opposite” bank of site one (Fig. 2). The area consisted of a well-developed riparian area, and bank sloping was not necessary. For the most part, the stream within this reach was a slow moving deep pool. However, the streambank was mostly gravel soil and became severely eroded from flooding and receding waters. The remediations of site two were as follows: at the upstream end of the project, a log deflector (Fig. 5) was constructed to deflect the erosive flow back towards the thalweg and away from the exposed bank (Fig. 2).

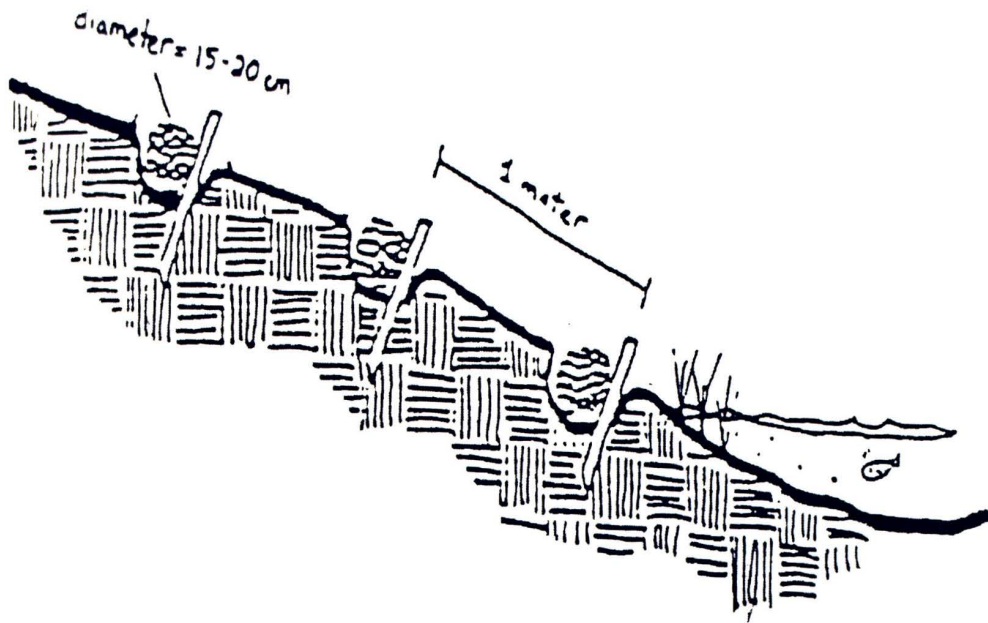
Fig. 9: Fascine bundle design and installation

Site five is another major success story. The fascine bundles of river cane have sprouted, spread by rhizome, covered the streambank, and held it in place (Fig. 9). The streambank has compacted well. The area was rebuilt with excess soil from sloping activities on Carr Creek. The bank has not been compromised in any way (no shear stress). There has been no movement or net loss in the rock toe revetment. Additional trees such as buckeye, box elder, sycamore, and cottonwood have taken root and are growing well throughout the area. Various oaks, tulip poplars, and silky dogwoods were planted to increase diversity and “re-build” the riparian zone.

streambank revetment (Fig. 8). Enough geotextile fabric was left at the toe region to “wrap” over the newly constructed toe, and provide a 3 m wide filter barrier between the rip-rap and streambank toe – stream interface. Limestone rock was then placed on top of the fabric to create a continuous had point for toe protection. Fascine bundles of River Cane were planted in rows from the top of the rock toe to the top of the streambank (Fig. 9).
